PT 501 Roller bearing faults

Description

- assessment of bearing condition by vibration analysis
- comparison of bearings with different faults

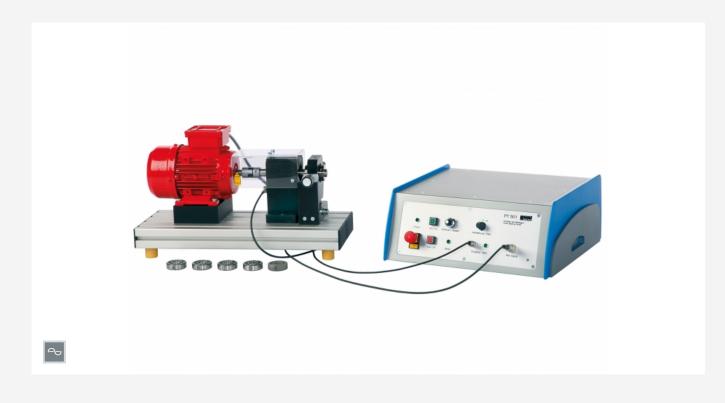
PT 501 contains six interchangeable roller bearings on which different faults can be detected and explained. The radial load on the bearing is set within broad limits using the loading device.

An electric motor with variable speed via frequency converter is used as drive. An acceleration sensor with measuring amplifier serves to measure the vibrations at the bearing housing. The speed is measured with an optical sensor. The measured values are transmitted directly to a PC via USB. The software for vibration analysis is included. The analysis software offers the following features: two-channel oscilloscope for investigations in the time range; two-channel spectrum analyser for investigations in the frequency range; vibration measuring unit; envelope analysis for bump effects and roller bearing damage.
